# Manhole Inspection Summary

Manhole # S27I\_\_019MH

**Location** Address: **1000 S.Schroeder St.**

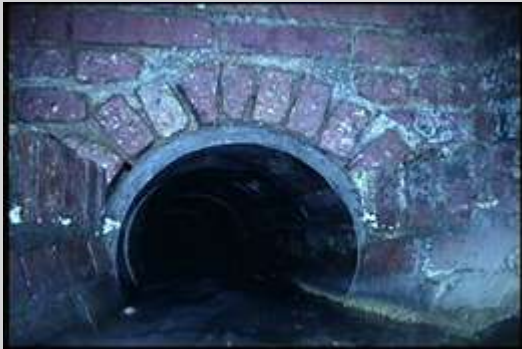
12 O'Clock Outflow

12 in. Circular Gravity Sewer  
Pipe Out @ 12 O'Clock

Pipe Height: **3.6** (in.) Direct (Angled)

Pipe Material: **Clay** ☐ Pipe Lined

Invert Depth: **10.80** (ft.) Flow Characteristics: **Fast**

Infiltration: **None** Pipe Seal Cond: **Sound**

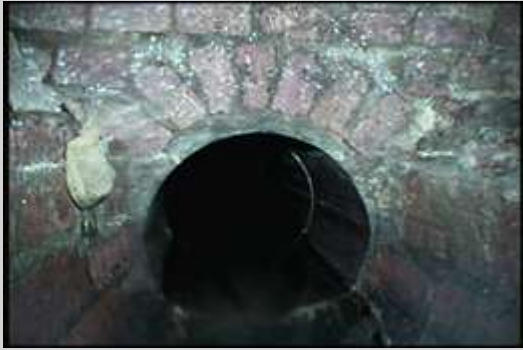
6 O'Clock Inflow

12 in. Circular Gravity Sewer

Pipe In @ 6 O'Clock

Pipe Height: **12** (in.) Rod and Bar (Angled)

Pipe Material: **Clay** ☐ Pipe Lined

Invert Depth: **10.66** (ft.) Flow Characteristics: **Fast**

Infiltration: **None** Pipe Seal Cond: **Sound**

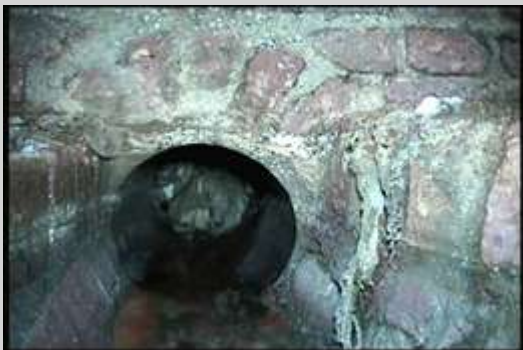
9 O'Clock Inflow

8 in. Circular Gravity Sewer

Pipe In @ 9 O'Clock

Pipe Height: **8.4** (in.) Rod and Bar (Angled)

Pipe Material: **Clay** ☐ Pipe Lined

Infiltration: **None** Pipe Seal Cond: **Sound**
